CONVEX

Field Support Tech Tip

Product: C-1

Subject: Multibus Chassis

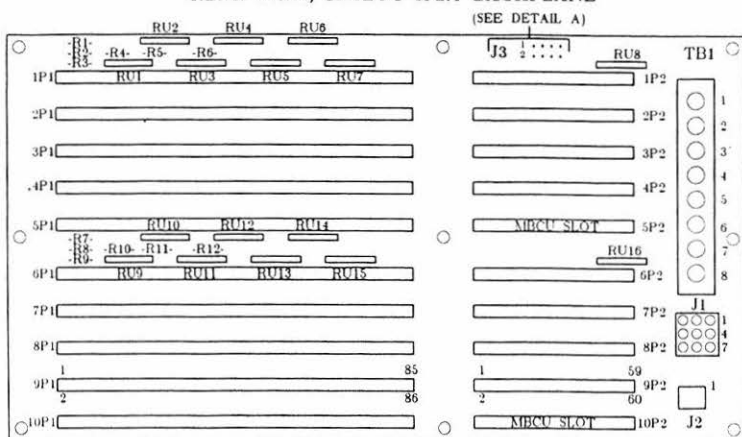
REAR VIEW, 10-SLOT SPLIT BACKPLANE

Normal Strapping is From 1 To 2.
Address 0, for both Slots 5 and 10.
NOTE: Address 1 is normally not used.

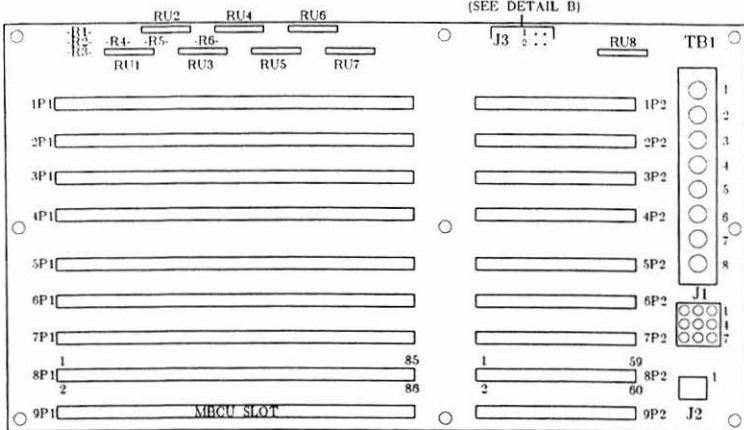
REAR VIEW, 9-SLOT NON-SPLIT BACKPLANE

Normal Strapping is From 1 To 2.
Address 0, for Slot 9.
NOTE: Address 1 is normally not used.
