**CONVEX**

**TECHNICAL BULLETIN**

**TABLE OF CONTENTS**

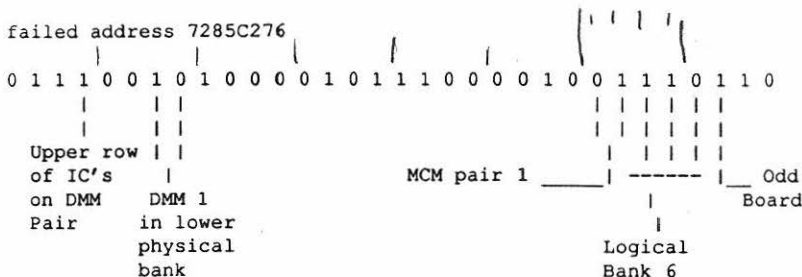
The example is for a system with 4 board pairs of fully populated MCM3's with 1MB DRAMS installed:

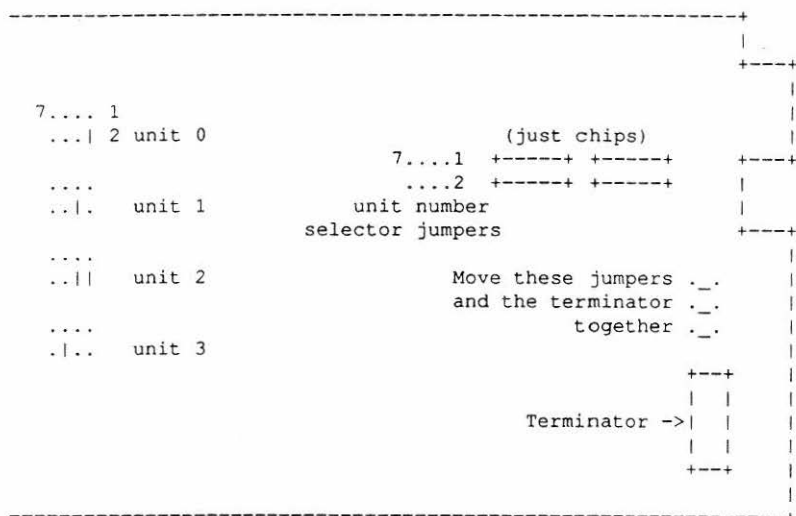
The terminator is placed on the last drive in the chain. If you move the terminator, you must also move the three jumpers located adjacent to the terminator
