OPD CUSTOMER ENGINEERING  
I/O Reference Manual  
Section 5

## I/O Diagnostic Aid Section 5

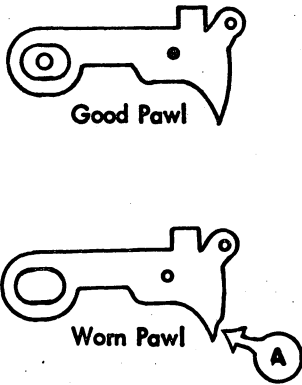
Figure 3.1

1.8 Backspace may go a full space but a worn escapement pawl will cause the carrier to skip ahead 1/2 space. See Fig. 3.1. Look for this condition under powered operation. To prevent a reoccurrence, replace the escapement pawl AND rack.

A worn pawl will be notched and polished at point "A".

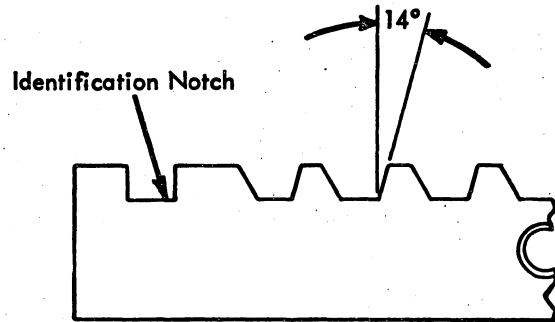
Figure 3.2

The pawl holding angle has been increased to improve escapement pawl life. The angle of inclination for the SELECTRIC I/O production escapement rack teeth has been reduced to 14°. This change has the effect of an increased escapement pawl to escapement rack holding angle, without necessitating a major change of design or of adjustment.

The 14° escapement rack has a milled notch (Fig. A) on the LH end. The new part numbers are listed below and should be added to your Keyboard or Keyboardless I/O Printer Parts Catalog.

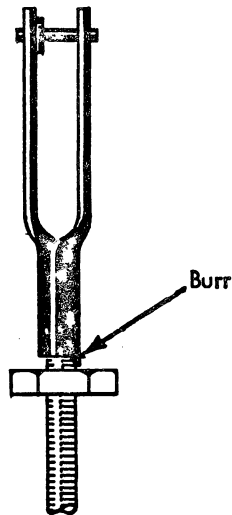
Figure 8.3

This burr cannot be removed due to manufacturing tolerances. A new design is anticipated very shortly.

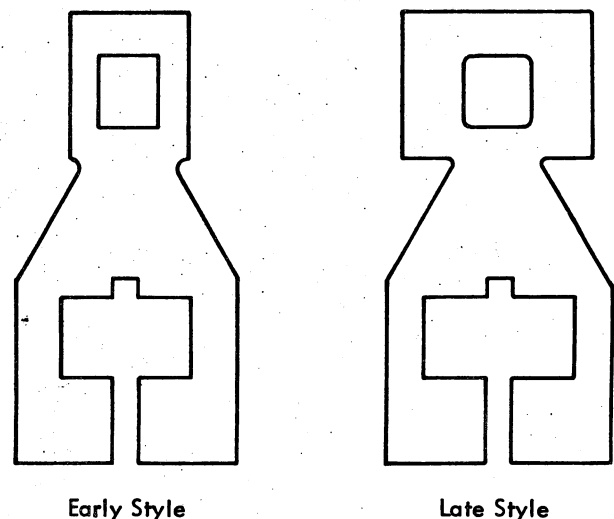
Figure 13.0

All new production machines incorporate a new Selector Latch Extension which has a larger structural surface and a rounded corner hole to prevent breakage, and insure positive positioning of the extension.

The new extensions may be recognized by their larger size (see illustration).

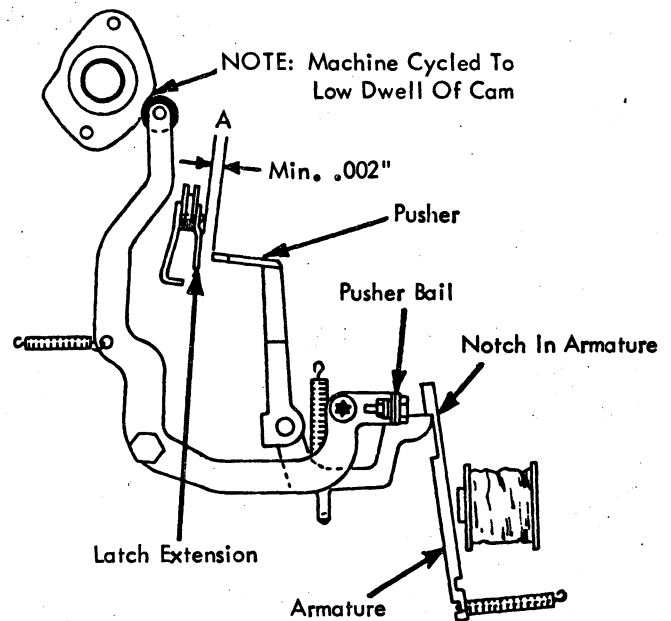
Figure 13.1

Mal-selection or parity errors may be caused by the latch pushers contacting their latch extensions when an unselected pusher is against its armature. There should be a minimum of .002" clearance (Fig. 1A) between the pusher and the latch extension when the pusher is against its armature. To check this adjustment, turn machine power off, trip the cycle clutch, and hand cycle a few degrees through a cycle. The pusher cam follower should be on the low dwell of the pusher cam.

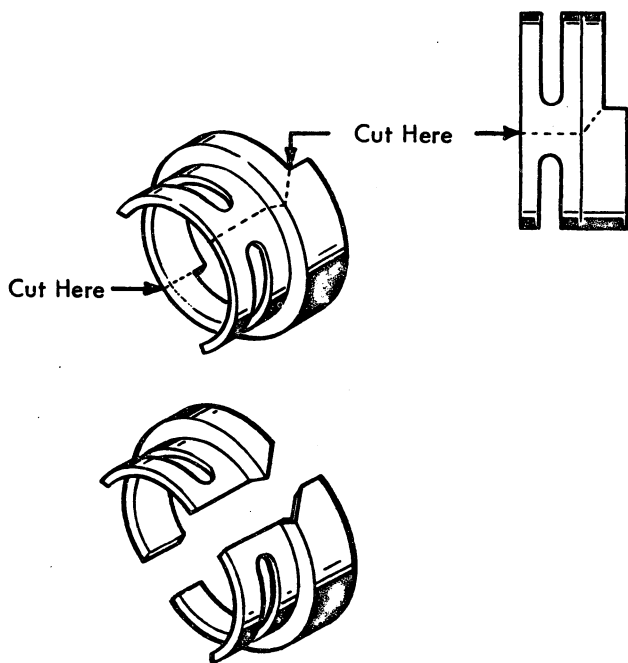
Figure 15.1

There have been instances where the cycle clutch restore cam will break or warp and require immediate replacement. A time-saving method of replacing the cycle clutch restore cam when it is not necessary to remove the cycle shaft is outlined below.

1. Remove the two locking screws and clips from the white nylon restore cam.
2. Cut the white nylon restore cam with a pair of dykes or wire cutters and remove the sections of the cam from the shaft.
3. Using a fine hacksaw or coping saw blade, cut a new cycle clutch restore cam as shown in Figure 1.

4. De-burr the two sections of the restore cam, place them on the cycle shaft, one at a time, and install their locking screws and clips.

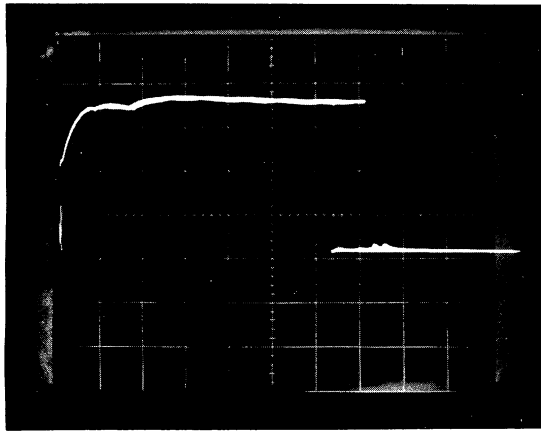
Figure 30.2

SLUGGISH PRINT ARMATURE  
CAUSED BY MALADJUSTED TRIP LEVER BITE

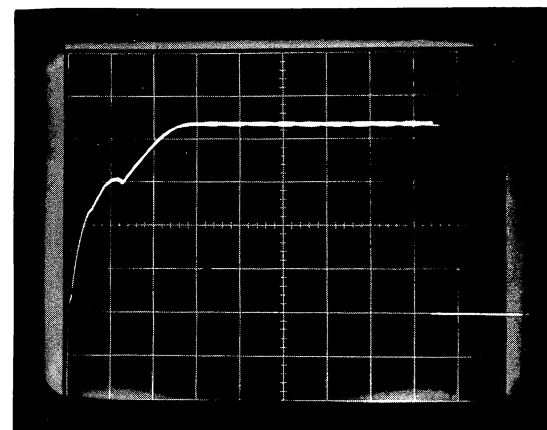
Figure 30.5

EXCESSIVE MECHANICAL DELAY

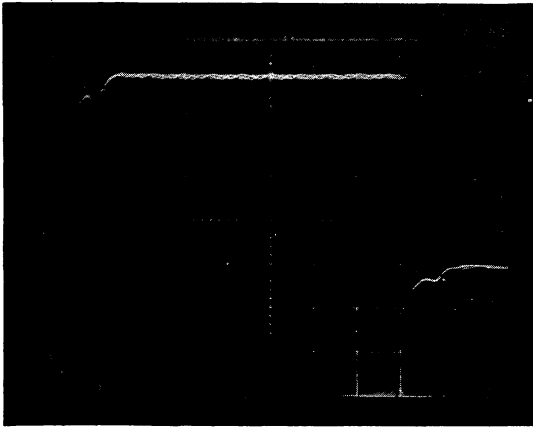
Figure 30.6

The distance in time between the teeth of the dog clutch ratchet is 14 ms. Normal operational cycles will vary in time depending on where the clutch pawl enters the clutch ratchet. This variation, however, should never exceed 14 ms. Any more variation would indicate worn pawls or ratchets.

Set OLSA to single cycle. Operate printer in short burst with the start pushbutton. Observe variation of pulse length. The example shows a variation in pulse length of about 12 ms for the eight printer cycles recorded.

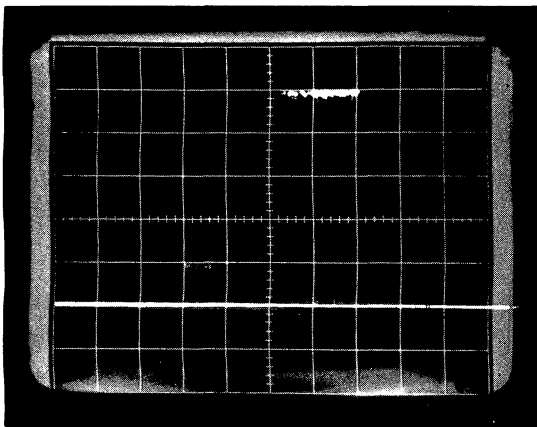
Figure 30.11

BOUNCING C1 N/O POINT
