OPD CUSTOMER ENGINEERING  
I/O Reference Manual  
Section 5

## I/O Diagnostic Aid Section 5

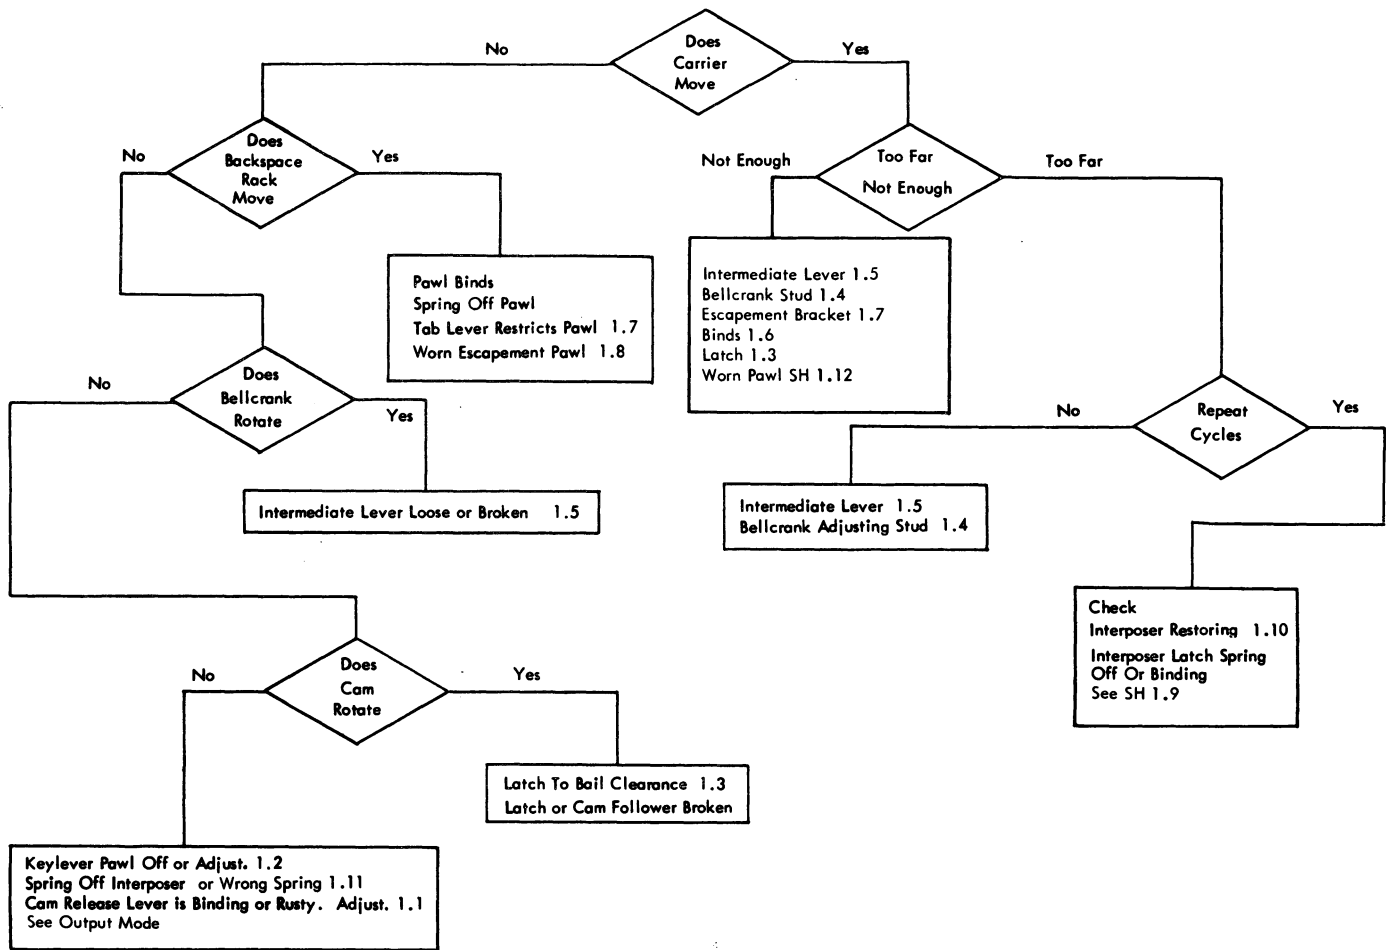
Figure 1.0

- 1.1 With the interposer and cam latched, form the Release Lug to obtain .035" - .045" clearance between the Interposer Lug and the Release Lever Lug.
- 1.2 The Keylever Pawl clears the interposer by .020" - .025".

- 1.3 The latch to bail clearance should be:
  - a. .003" - .015" Space/Backspace.
  - b. .003" - .010" Carrier Return/Index.
  - c. .003" - .015" Tab or Wordmark.

1.8 Backspace may go a full space but a worn escapement pawl will cause the carrier to skip ahead 1/2 space. See Fig. 3.1. Look for this condition under powered operation. To prevent a reoccurrence, replace the escapement pawl AND rack.

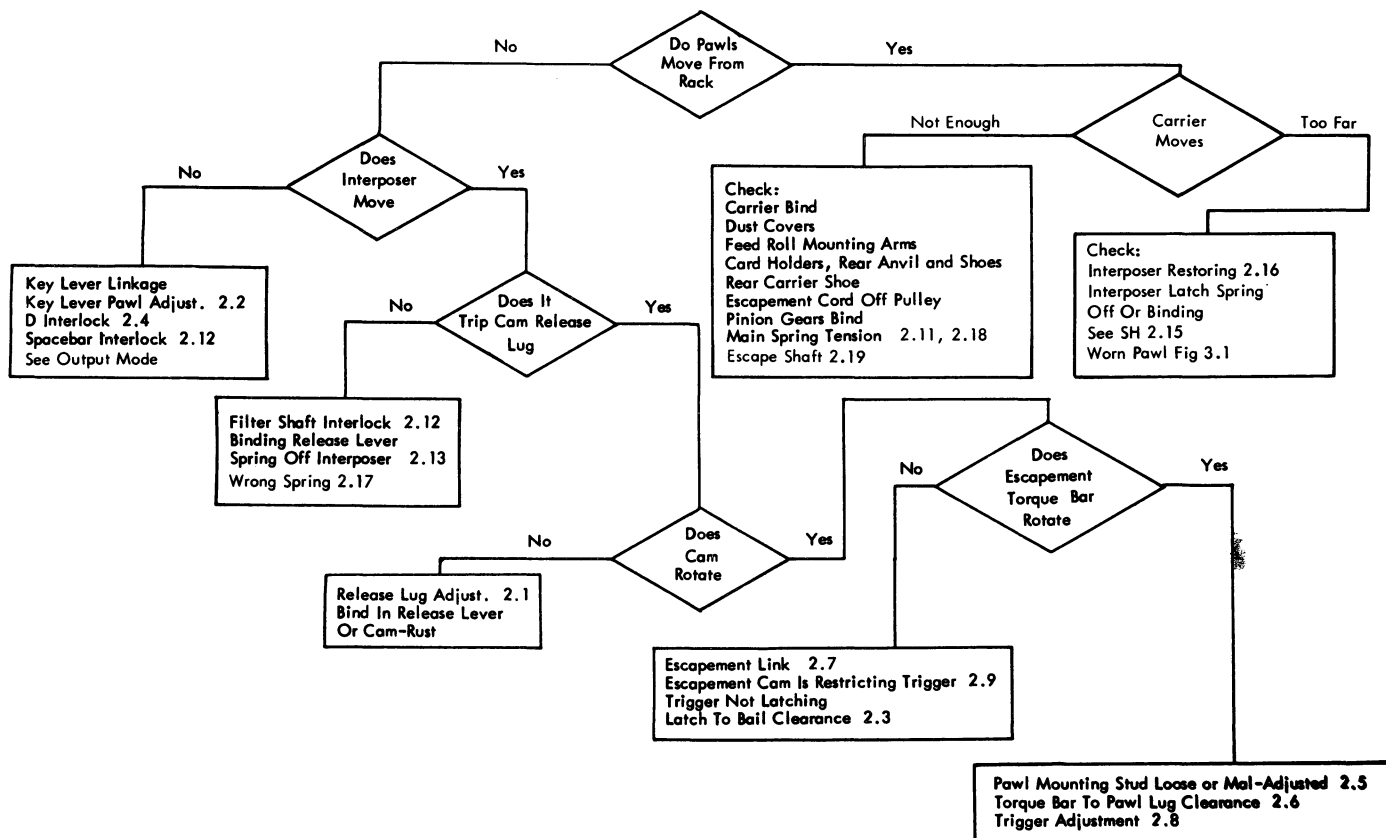
Figure 2.0

Intermittent space failures can be caused by excessive cycle clutch overthrow or incorrect print escapement cam timing.

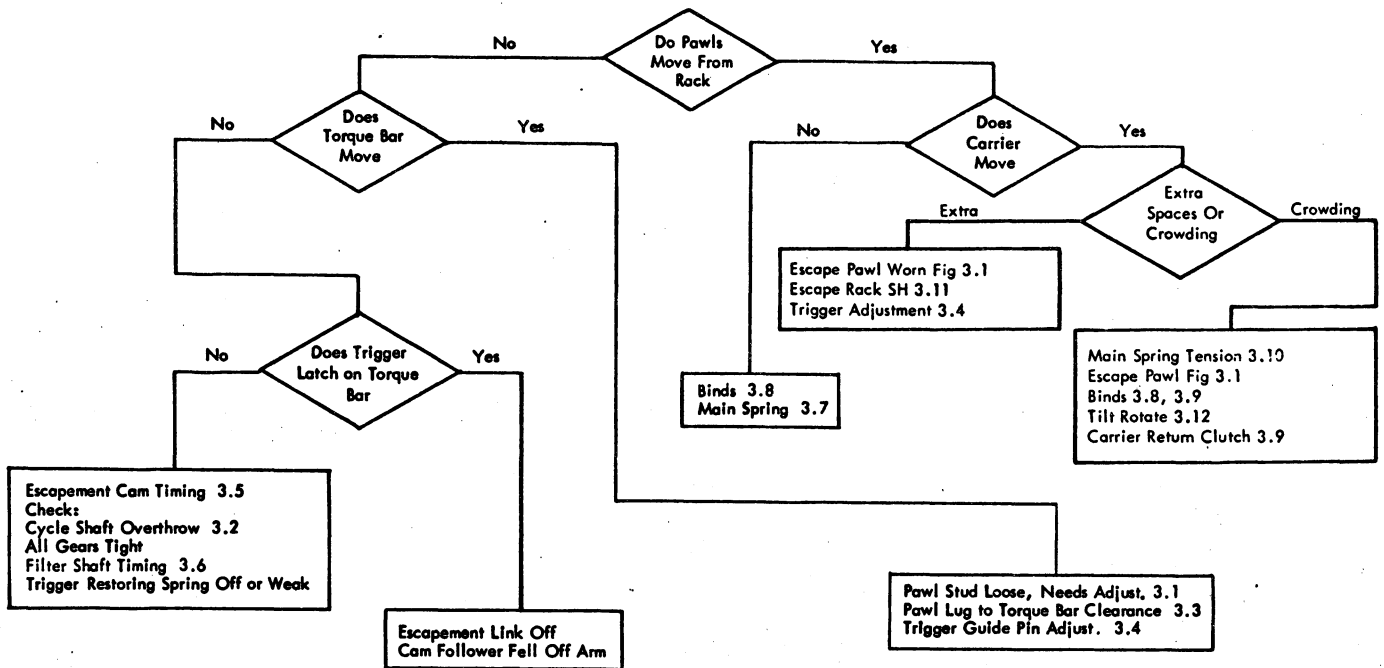
Figure 3.0

A worn pawl will be notched and polished at point "A".

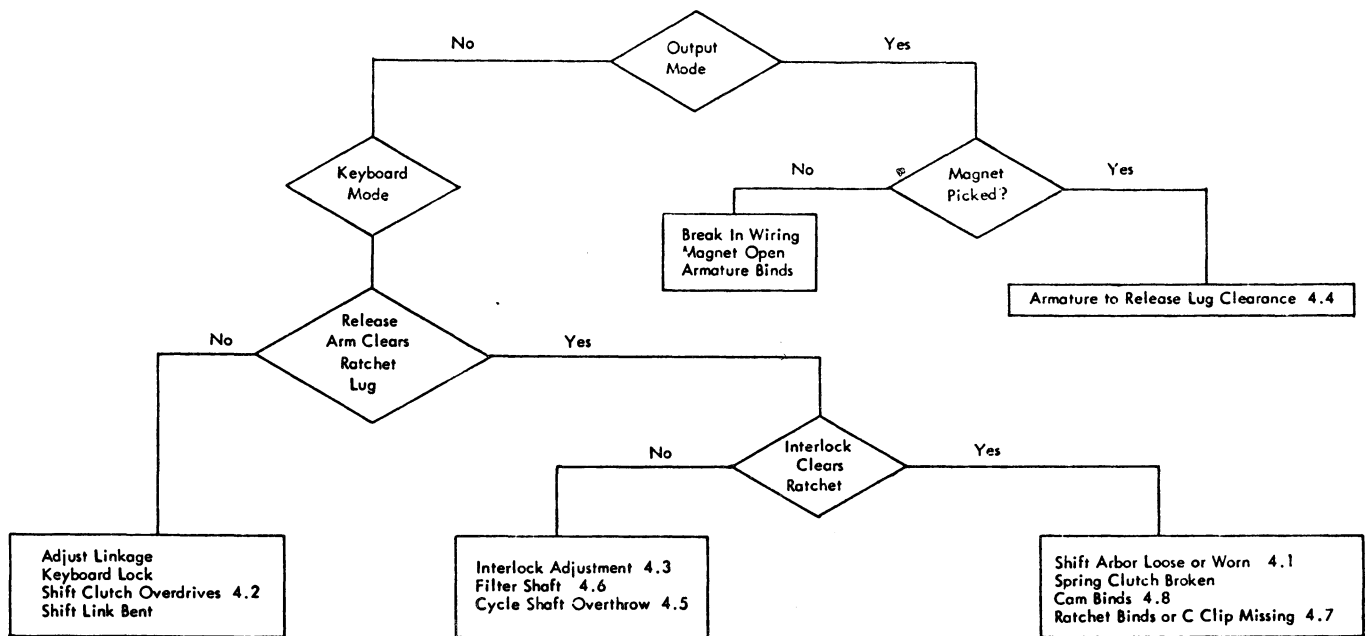
Figure 4.0

- 4.1 The shaft end play should be .002" - .004". If the Shift Arbor comes loose, a new set screw is available (PN 257969) which will lock the arbor securely on the shaft.

- 4.7 Binds in the Shift Cam may be caused by maladjustment of the Shift Back-up Roller. Adjust for .002" - .004" clearance between the cam in lower case. A Spring Hook Pusher end may be used to adjust the Back-up Roller eccentric stud.

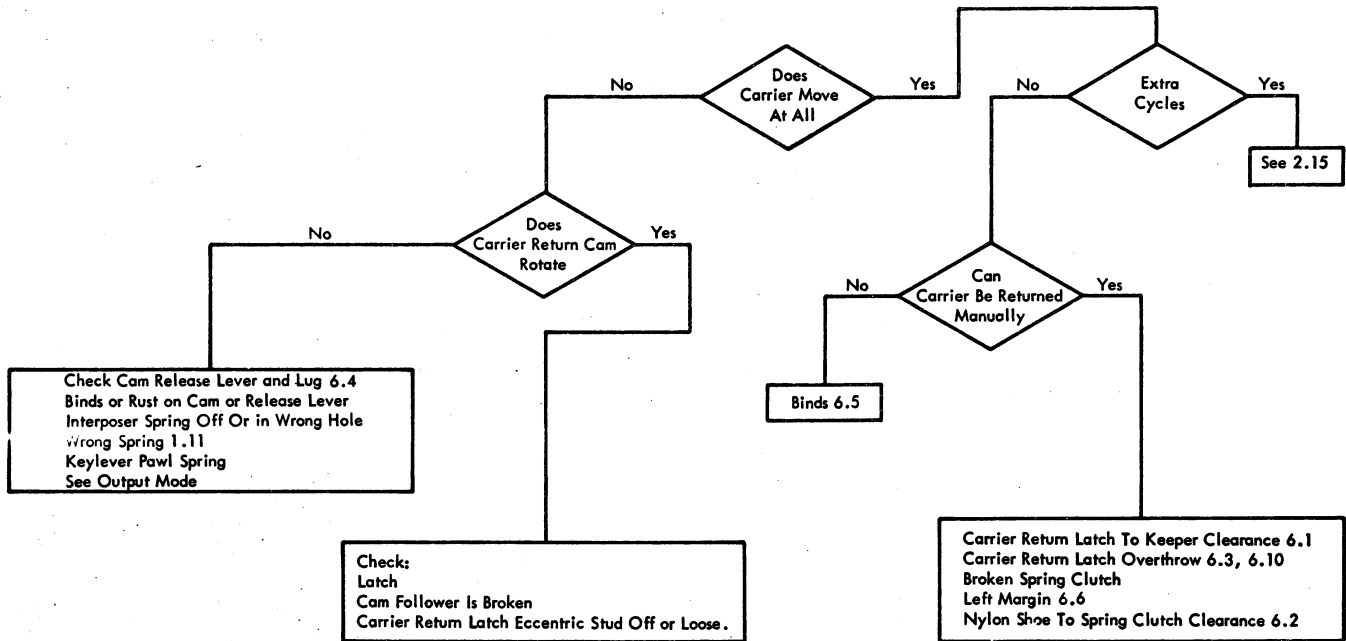
● Figure 6.0

- 6.1 With the Margin Rack held to the left, adjust the unlatching link so that the keeper clears the actuating arm by .005" - .015".
- 6.2 Adjust for a minimum of .010", maximum of .020" clearance between the C/R Shoe and the Spring Clutch. Note: The Carrier Return Spring Clutch Clamp may be off or broken.

- 6.6 An uneven left margin may be caused by:
- a. The Clutch Unlatching Link being too short.
  - b. The overbank adjustment.
  - c. A worn Escapement Pawl. (Fig. 3.1)

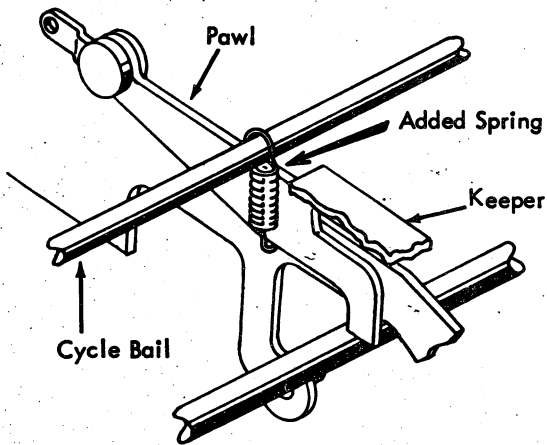
Figure 12.0

Pawl bite should not exceed 1/2 the thickness of the keeper. Adjust the cycle bail upstop. This will maintain a clearance of .010" - .020" between the cycle bail and the interposers. With this clearance the cycle bail will not be able to bounce on the interposers.

A spring, PN 1090343, may be added between the cycle clutch trip bail and the cycle clutch pawl to reduce bail bounce (Fig. 12.1).

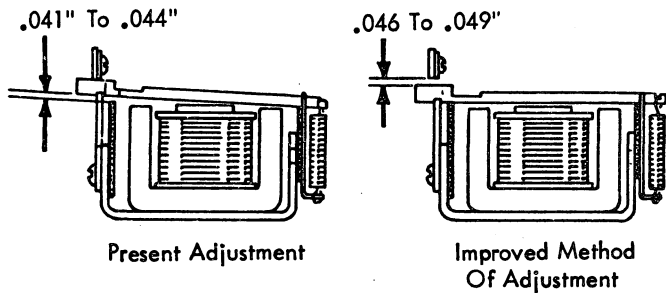
Figure 14.1

Manually attract the magnet armature and insert a feeler gage between the armature and backstop (see Figure below). When checking it by this method the clearance should be .046" to .049". If the adjustment is found to be correct all preceding adjustments must be checked. It will be necessary to remove the magnet assembly for previous adjustments.

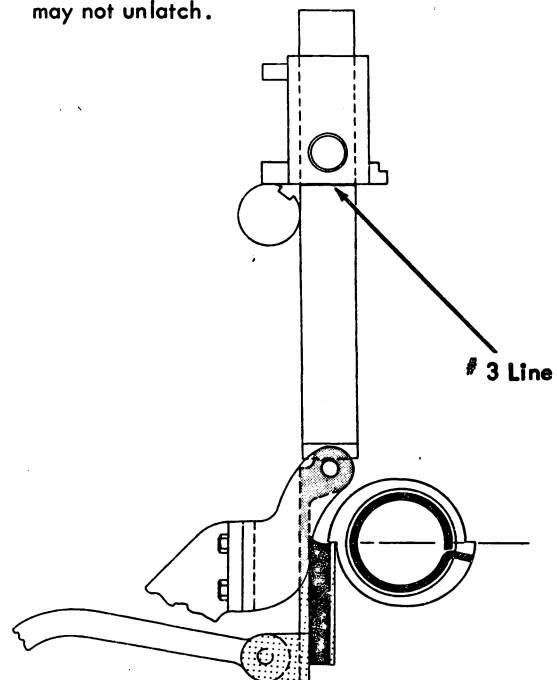
Figure 15.0

The cycle clutch latch height must always be checked before attempting cycle clutch collar adjustment (Fig. 15.1). If the latch is too high, extra cycles may occur. If the latch is too low, the cycle clutch may not unlatch.

Cycle clutch latch wear can be caused by the latching surface not being parallel to the cycle clutch sleeve. To insure that the latch is parallel to the sleeve, it should be adjusted in the following manner:

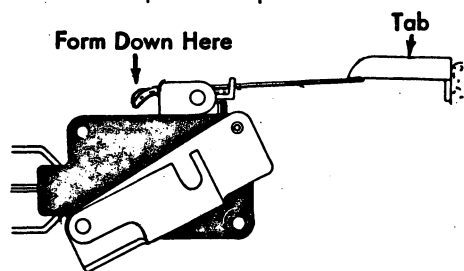
Figure 21.0

If the actuating wire pops out from under the torque bar actuating arm, form the rear section of the actuating wire to provide an overthrow stop for the wire (Figure 22.1). See the I/O Printer Reference Manual for the specific adjustments.

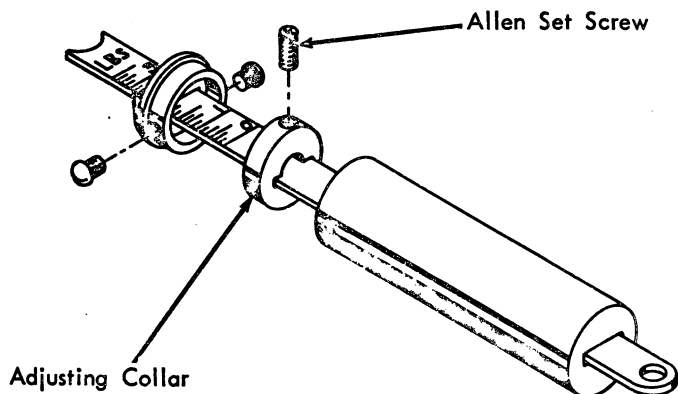
Figure 22.0

Many adjustments made in the field require the use of spring scale, PN 9900012. Reports indicate that the accuracy of the scale is impaired due to the zero adjustment being incorrect before measurements are made. The zero adjustment can be made by removing the two screws that fasten the end cap, and removing the end cap. This exposes an adjustable collar secured by a #4 Allen screw. The zero adjustment can be made by loosening the Allen screw and repositioning the collar on its shaft. The hook may have to be removed from the scale to allow the shaft to move far enough to expose the Allen screw; however, the hook should be replaced when checking the zero adjustment. Correct adjustment is checked by holding the scale in the upright position (hook hanging down) and observing that the scale reads exactly 0.

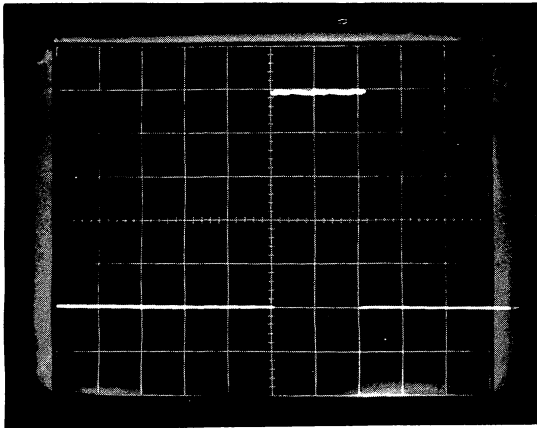
Figure 30.10

Shown is the scope pattern seen on C2 operating point when Selectric I/O is attached to OLSA. This is a normal signal reflecting inductive spikes generated by OLSA relays. These spikes do not originate in the Selectric I/O.
